College sector estates condition survey

Reference: SFC/CP/05/2017

Gardiner & Theobald's report: College Estate Condition Survey

SCOTTISH FUNDING COUNCIL
College Estate Condition Survey

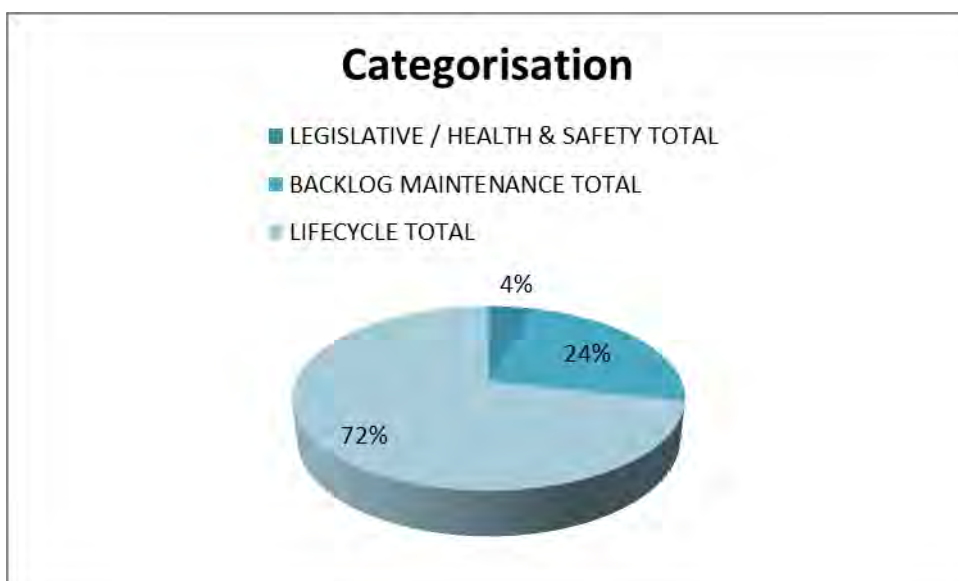
1.13. The charts below and overleaf present a visual representation of the breakdown of the backlog maintenance and renewals cost by priority, categorisation and elemental split between building fabric and building services: -

Elemental

■ BUILDING FABRIC TOTAL ■ M&E SERVICES TOTAL

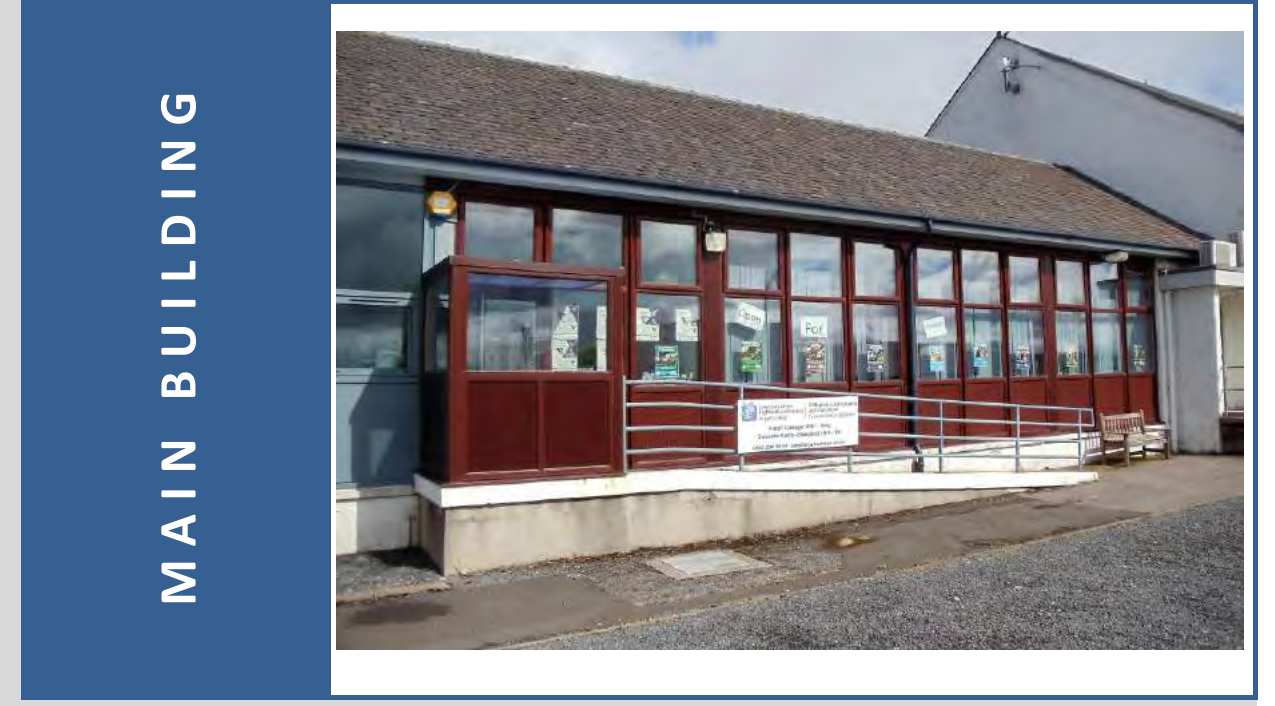
WHOLE CAMPUS CONDITION SUMMARY

IDENTIFICATION	COLLEGE : ARGYLL	 Copyright © 2017 MAMG Consultancy	DETAILS
	CAMPUS : ISLAY		
ADDRESS: St No. (if any): Street: Flora Street Town: Bowmore (Island): ISLAY Post Code: PA43 7JY			
Approx Total Gross Internal area : 84		(* Important note: area is approx. only and may be from scaled aerial images or other information provided by others, not validated or to be used for any other purpose)	
Date ranges of Construction : 1978 - 2012

CAMPUS CONDITION & COST SUMMARY	PLAN REF	BUILDING NAMES	AVERAGE CONDITION	CONDITION SPREAD %				BUDGET COSTS - 5 YEAR OUTLOOK: BACK-LOG MAINTENANCE & RENEWALS (Excl VAT & Fees)*					RELATIVE INDICATOR	
				A	B	C	D	BUILDING TOTAL	£/m2	YEAR.1. VERY HIGH	YEAR.2. HIGH	YEARS 3-4 MEDIUM		YEAR.5. + LOW
								£	£	£	£	£		£
	01	Islay High School - Leased Rooms	B	18	76	5	1	£ 40,165	£ 478	£ 11,880	£ 24,319	£ 858	£ 3,108	
	02													
	03													
	04													
	05													
	06													
	07													
	08													
	09													
	10													
	11													
	12													
	13													
	14													
	15													
	16													
	17													
	18													
	19													
	20													
							TOTALS *	£ 40,165	£ 478.15	£ 11,880	£ 24,319	£ 858	£ 3,108
